# **Wetland Delineation Report - DRAFT**

## ***Plymouth Creek Feasibility Study***

Prepared for  
Bassett Creek Watershed Management Commission

January 2016

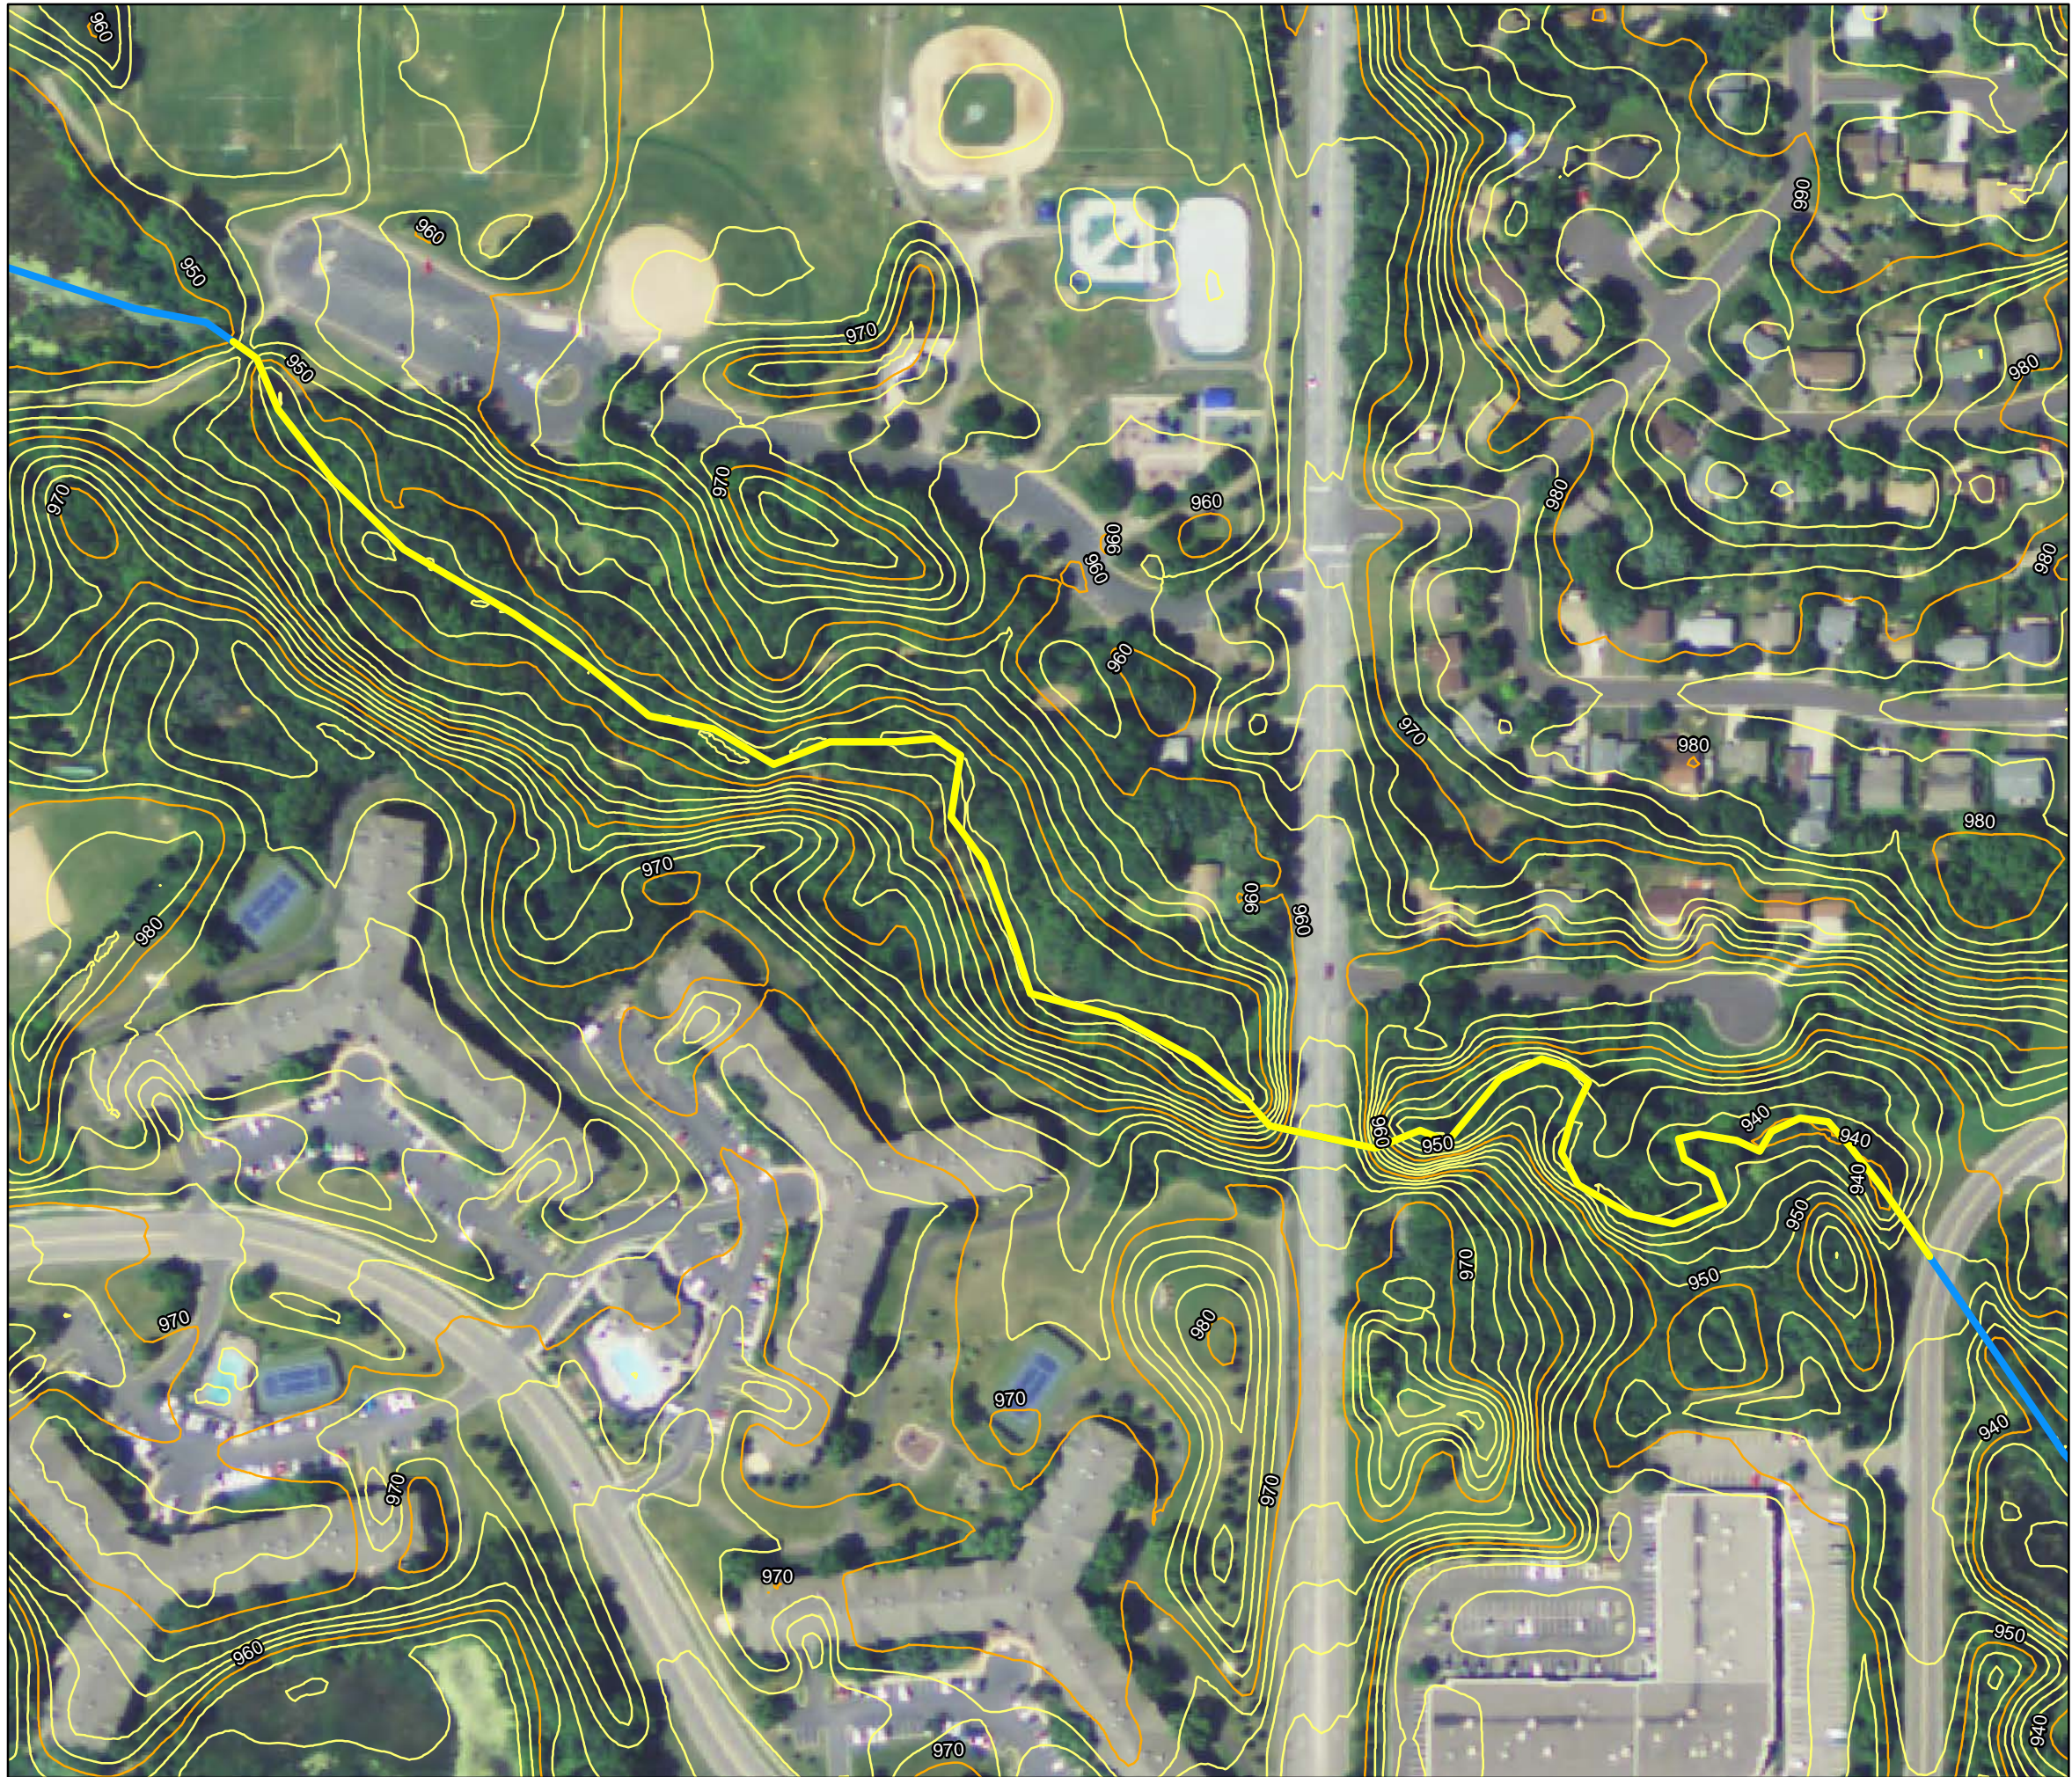
Figure 2

The project area has moderately undulating to flat topography throughout and in most areas along Plymouth creek there is an abrupt topographic break leading into the creek due to erosion. Topography surrounding the project area further away is relatively flat (**Figure 2**).

TOPOGRAPHY MAP  
Plymouth Creek Feasibility Study  
Wetland Delineation  
Bassett Creek Watershed  
Management Commission

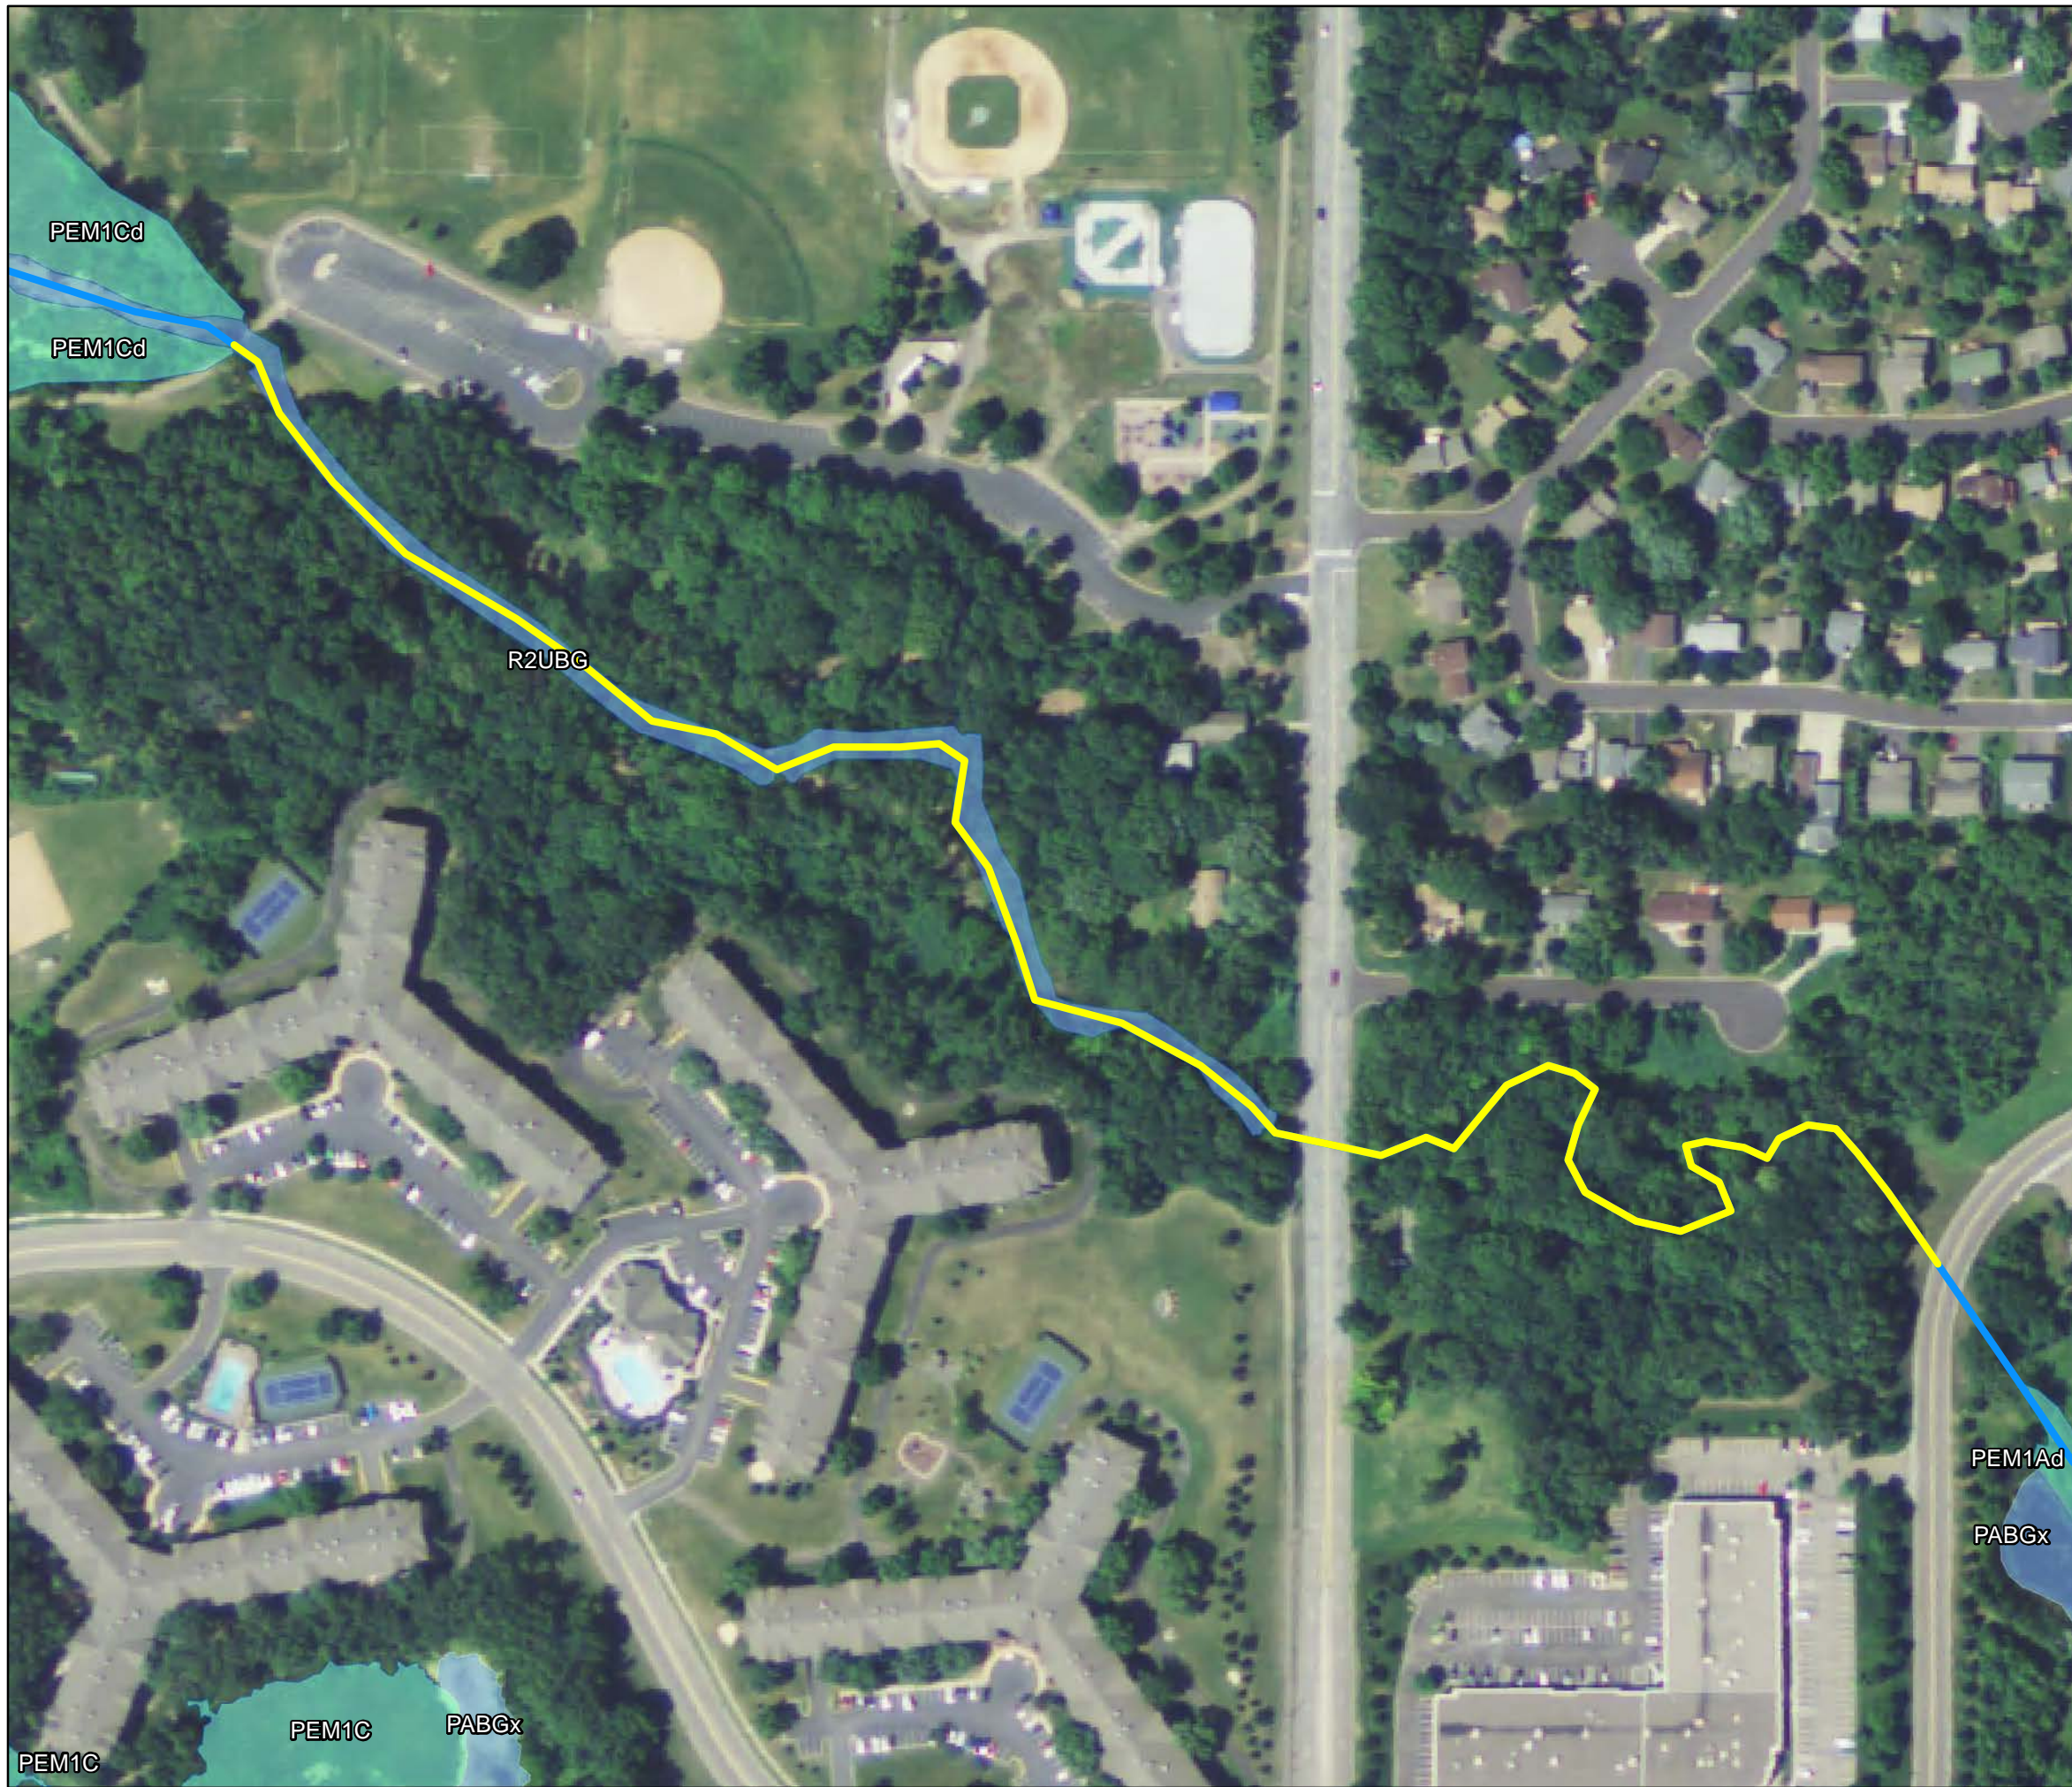
Figure 3

The National Wetland Inventory (NWI) Map has identified a portion of the Plymouth Creek Study Reach as riverine wetland located west of Fernbrook Lane North. It was identified as a riverine (R) wetland, lower perennial (L), with an unconsolidated bottom (UB) that has an intermittently exposed hydrologic regime (G) or an R2UBG riverine wetland. No other NWI wetlands were mapped within the Plymouth Creek Study Reach (**Figure 3**).

NATIONAL WETLAND INVENTORY  
Plymouth Creek Feasibility Study  
Wetland Delineation  
Bassett Creek Watershed  
Management Commission

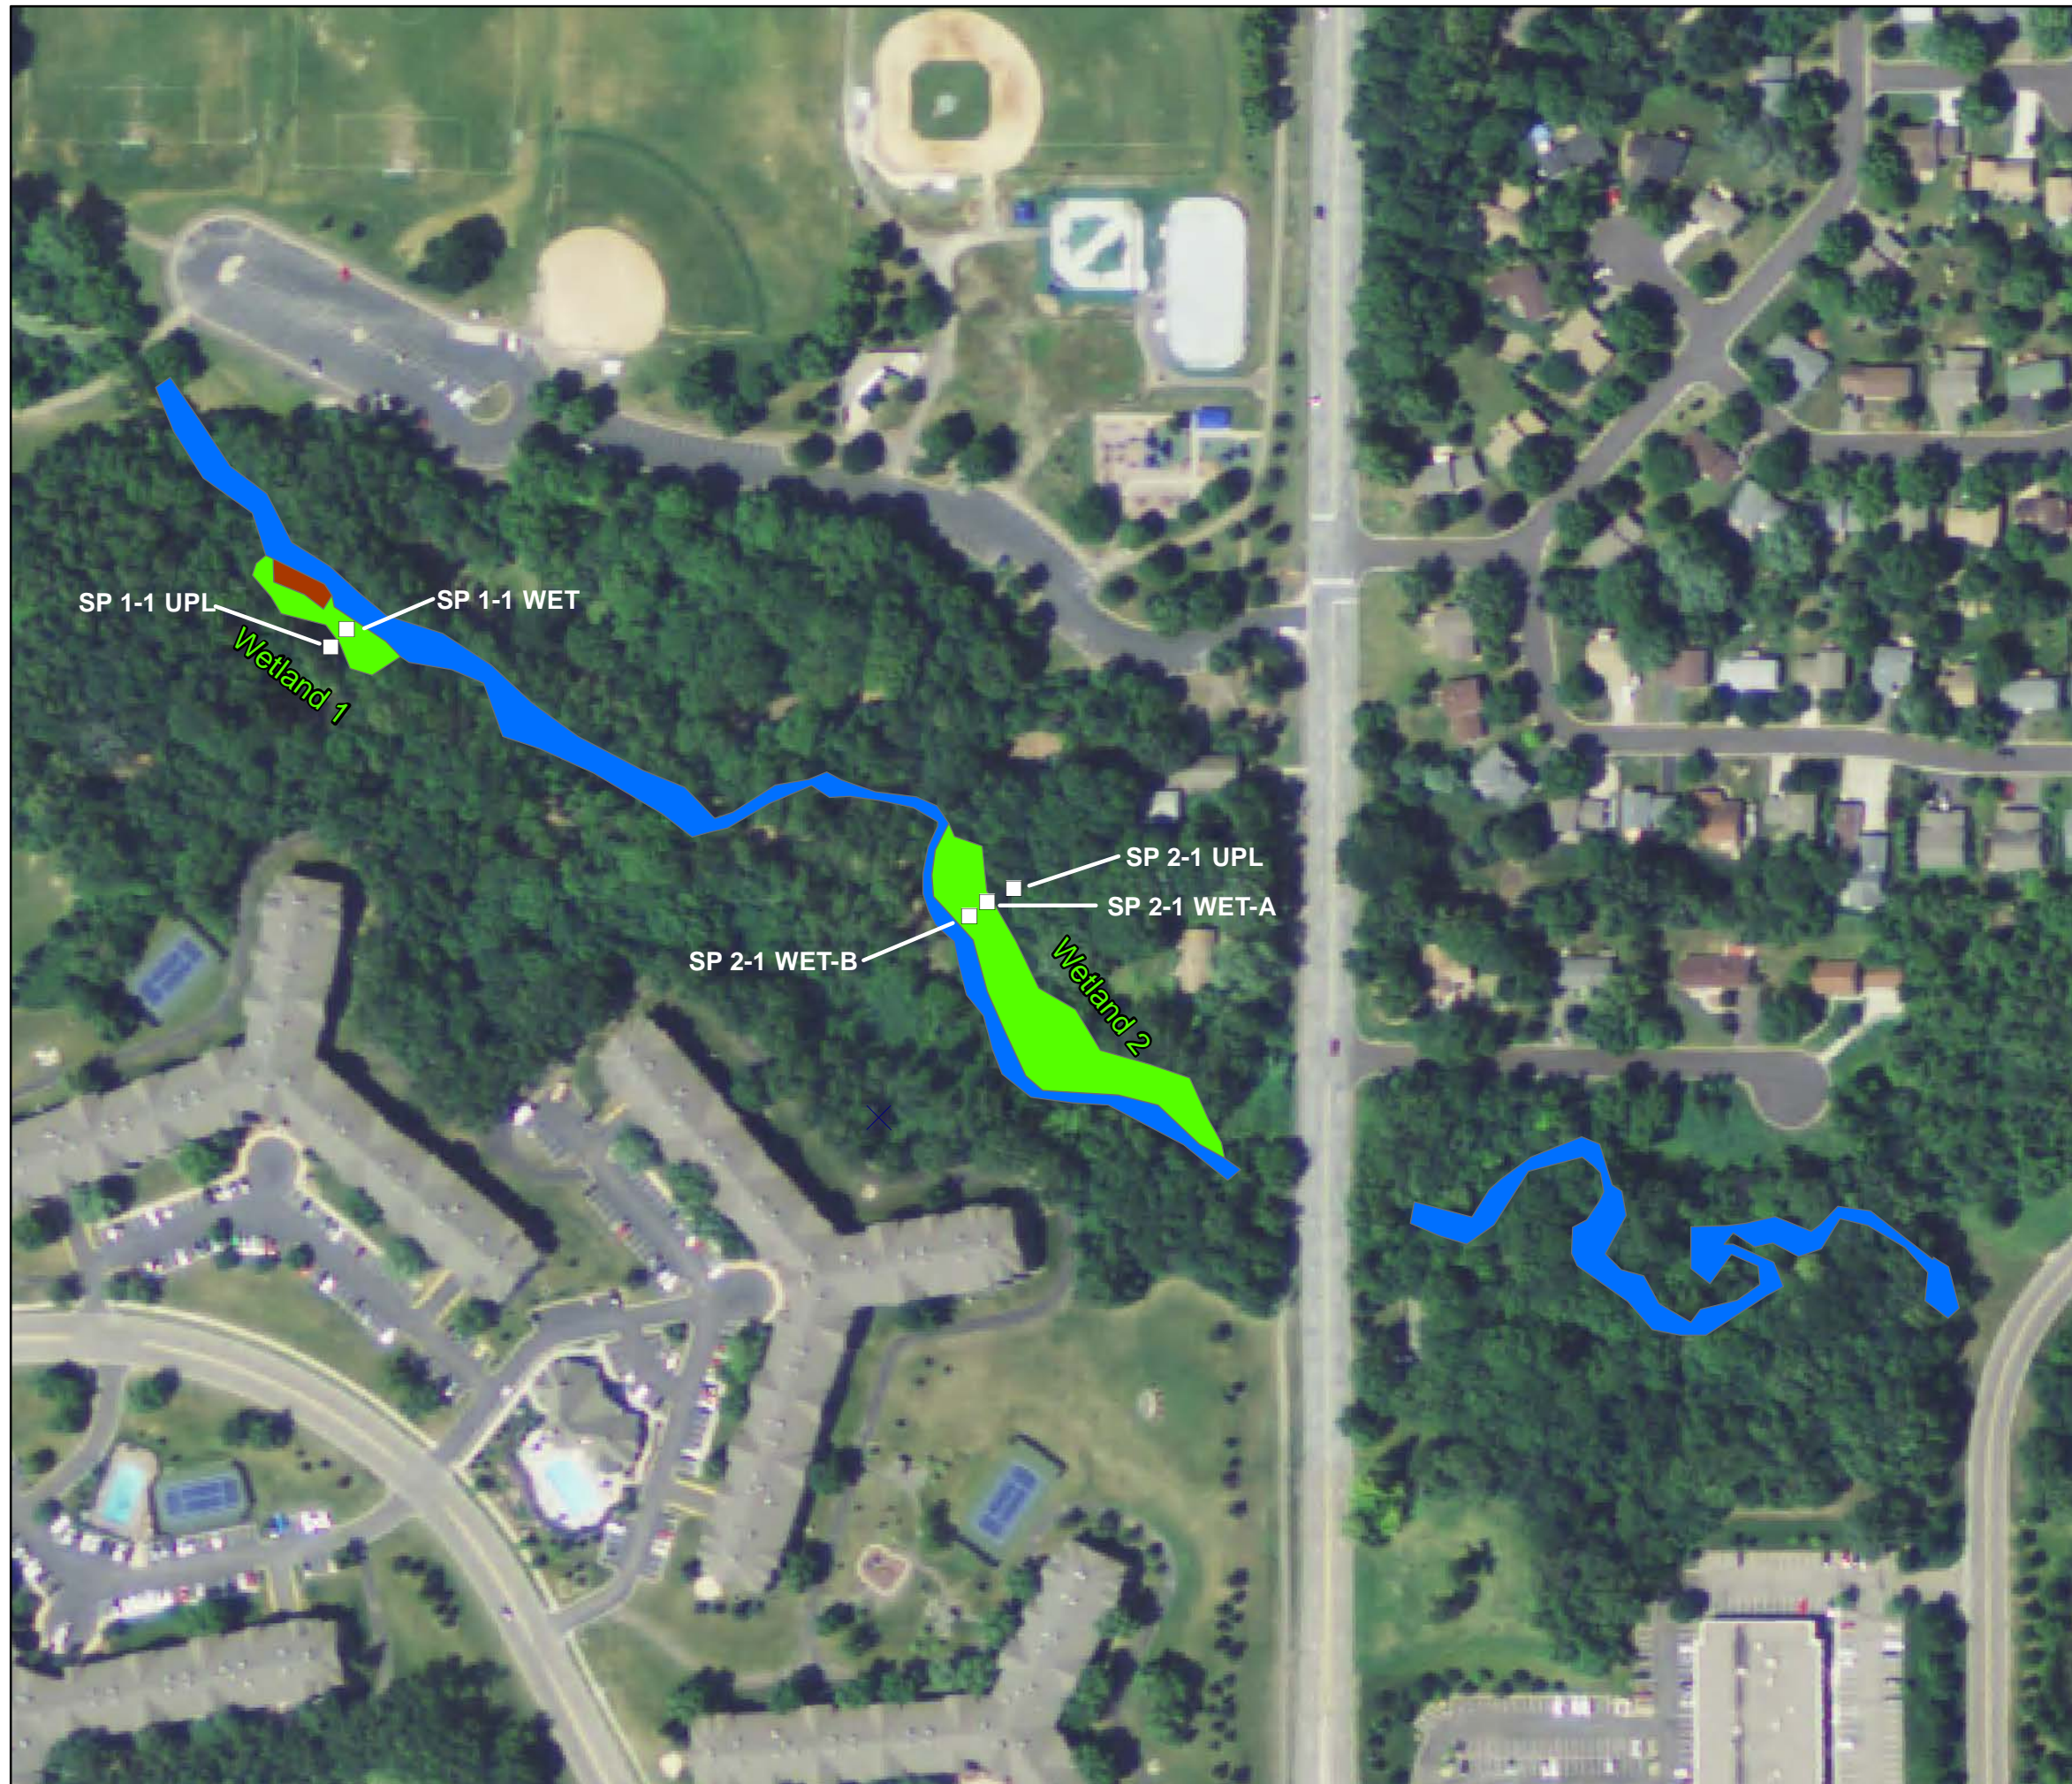
Figure 6

A field wetland delineation was conducted along the fringes of these stream reaches to include delineation of creek edges. Two wetland boundaries were delineated along the creek fringes and are depicted in **Figure 6**.

The delineated wetland boundaries and sample points were surveyed using a Global Positioning System (GPS) with sub-meter accuracy (**Figure 6**).

Wetland 1 is a Type 1 (PEMA), seasonally flooded basin within floodplain located on the right bank of Plymouth Creek within Plymouth Creek Park (**Figure 6**). The surrounding area has steep and abrupt slopes leading into Wetland 1. There is an upland island between Wetland 1 and Plymouth creek approximately 8 feet higher in elevation than the surface of the wetland. Flood waters may periodically enter the north end of Wetland 1 between the upland island and the adjacent forested uplands to the south, which flow through and back to Plymouth Creek further downstream.

Wetland 2 is a Type 2 (PEMB), fresh meadow located on the left bank of Plymouth Creek approximately 300 feet downstream from Wetland 1 (**Figure 6**). Wetland 1 may occasionally flood during the growing season but in most year's water likely remains within 12 inches of the soil surface. Two sample points were taken within Wetland 1 along the same transect. Data from SP 2-1 WET-A was collected close to the wetland boundary and data from SP 2-1 WET-B was collected closer to the creek channel.

WETLAND & CREEK DELINEATION  
Plymouth Creek Feasibility Study  
Wetland Delineation  
Bassett Creek Watershed  
Management Commission

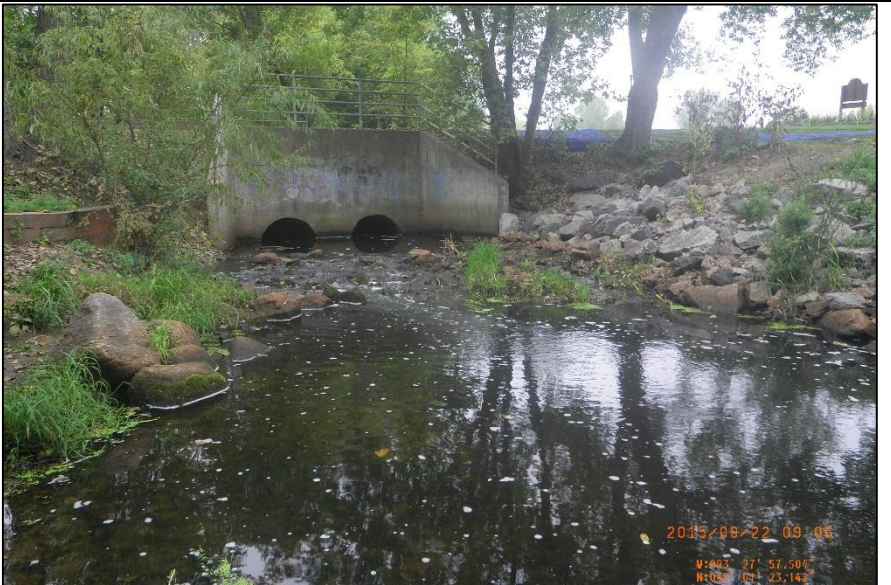
<p><b>Photo 1</b> – September 22, 2015</p> <p>Study Reach (West of Fernbrook Ln. N)</p> <p>Water-level-control structure at start of the survey within Plymouth Creek Park.</p>

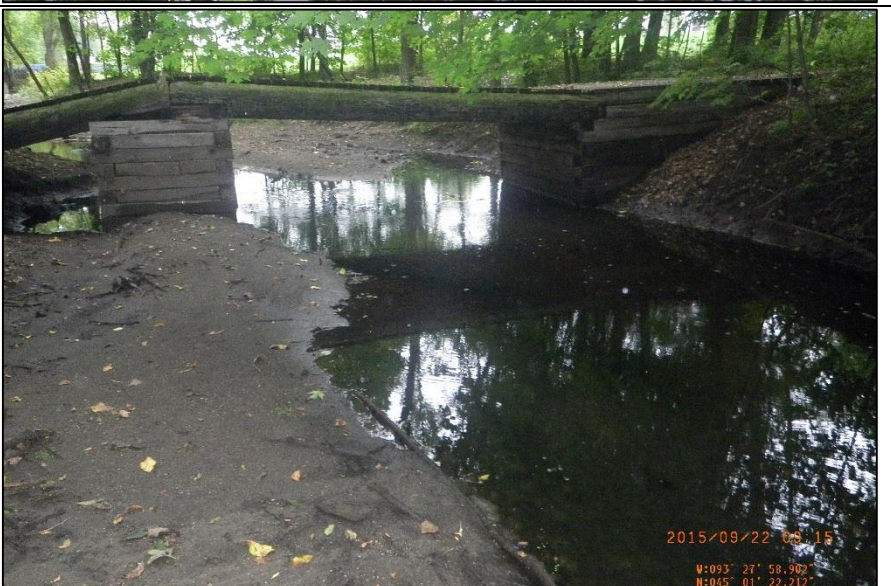
<p><b>Photo 2</b> – September 22, 2015</p> <p>Study Reach (West of Fernbrook Ln. N)</p> <p>Bridge crossing and typical view of Plymouth Creek in this area.</p>

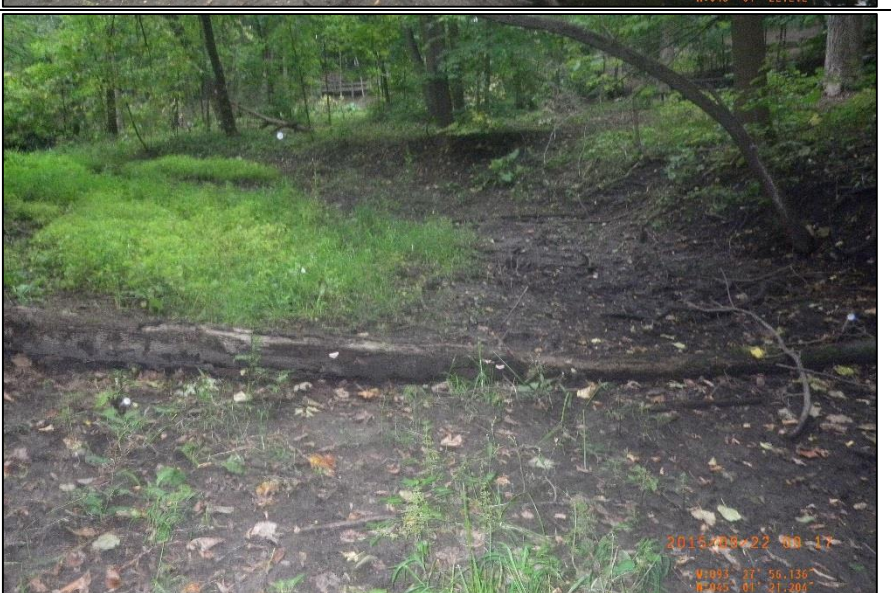
<p><b>Photo 3</b> – September 22, 2015</p> <p>Wetland 1</p> <p>Facing southeast. This photo shows the eroded edge of Wetland 1 and saturated soils.</p>

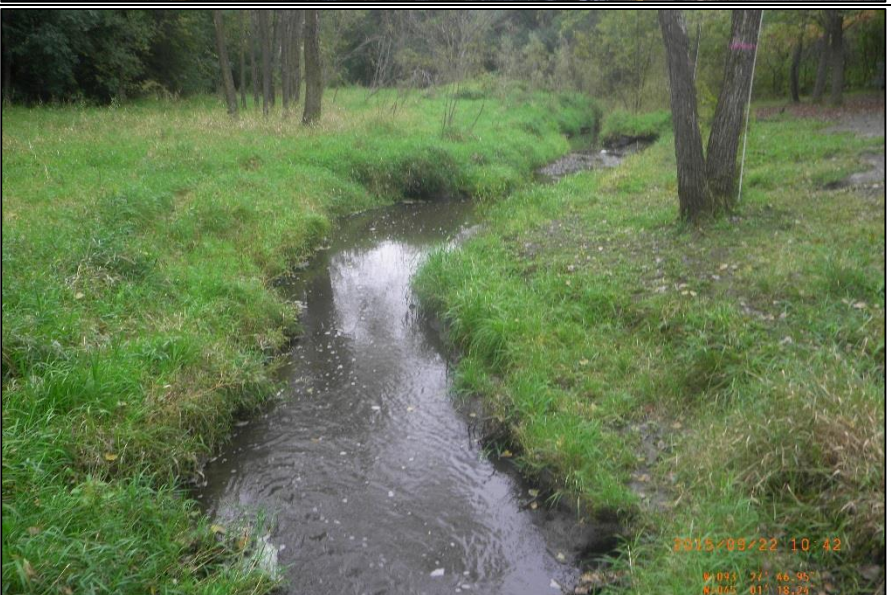
<p><b>Photo 4</b> – September 22, 2015</p> <p>Wetland 2</p> <p>Facing northwest. The upland island is located on the right side of the photo.</p>	  <p>2015/09/22 09:19 N: 091° 01' 55.974" E: 005° 01' 00.130"</p>
<p><b>Photo 5</b> – September 22, 2015</p> <p>Study Reach (West of Fernbrook Ln. N)</p> <p>Typical view of the stream reach between Wetlands 1 and 2</p>	  <p>2015/09/22 09:16 N: 091° 21' 50.442" E: 005° 01' 25.720"</p>
<p><b>Photo 6</b> – September 22, 2015</p> <p>Wetland 2</p> <p>Facing south at the north edge of Wetland 2. Wetland 2 is located on the left side of this photo.</p>

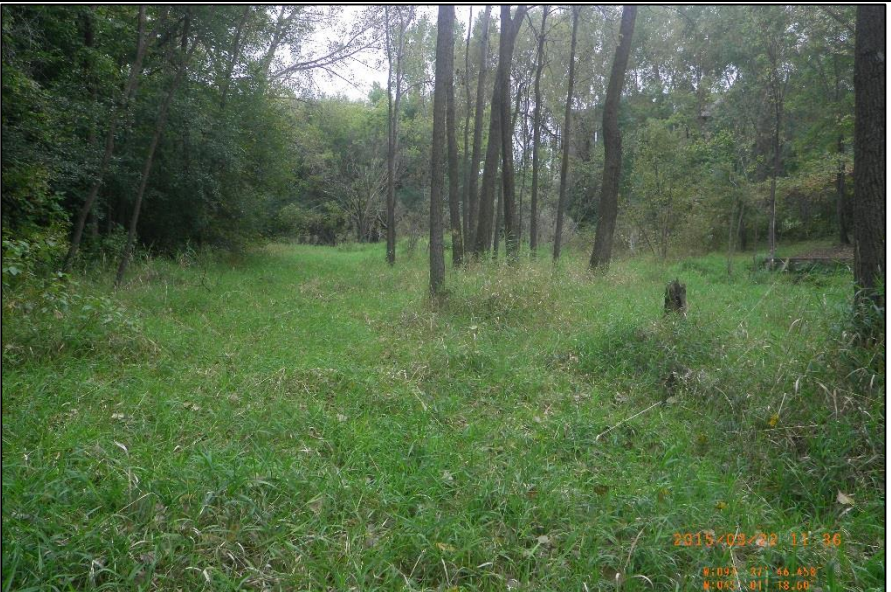
<p><b>Photo 7</b> – September 22, 2015</p> <p>Wetland 2</p> <p>Another view of wetland 2 facing southeast. Wetland 2 is dominated by reed canary grass.</p>

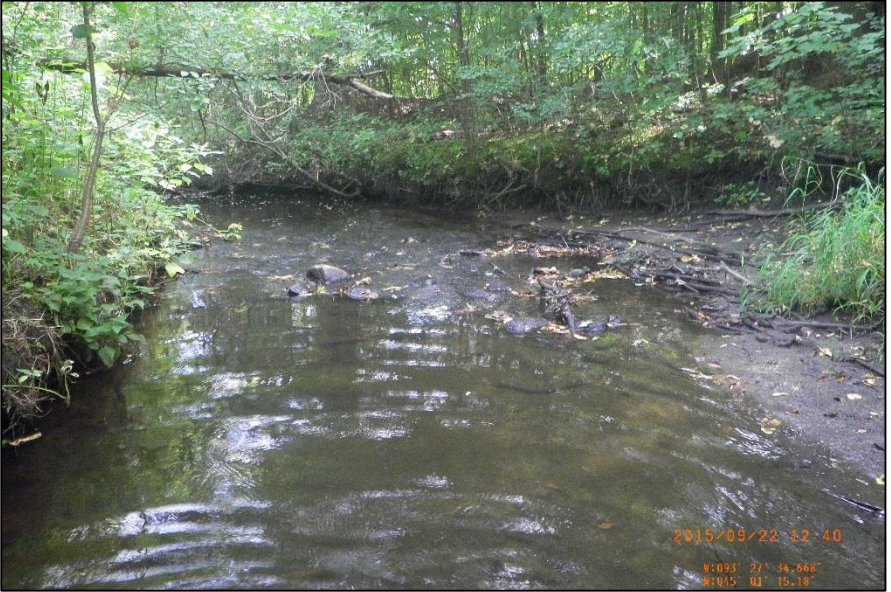
<p>2015/09/22 12:36 N: 034° 37' 46.450" W: 045° 01' 19.00"</p>
<p><b>Photo 8</b> – September 22, 2015</p> <p>Study Reach (East of Fernbrook Ln. N)</p> <p>This photo shows an undercut portion of stream channel, which is typical along many areas of Plymouth Creek.</p>

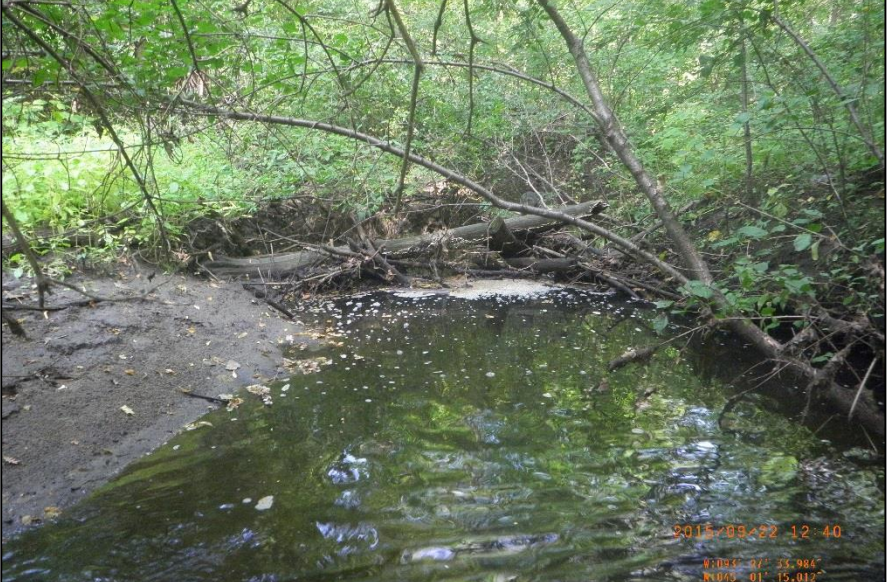
<p>2015/09/22 12:40 N: 034° 37' 44.884" W: 045° 01' 15.182"</p>
<p><b>Photo 9</b> – September 22, 2015</p> <p>Study Reach (East of Fernbrook Ln. N)</p> <p>Many areas within the stream reach east of Fernbrook Lane have snags that obstruct water flow</p>
